RECLAMATION REPORT

ORPHAN MINE

GRAND CANYON NATIONAL PARK, ARIZONA

June 1986

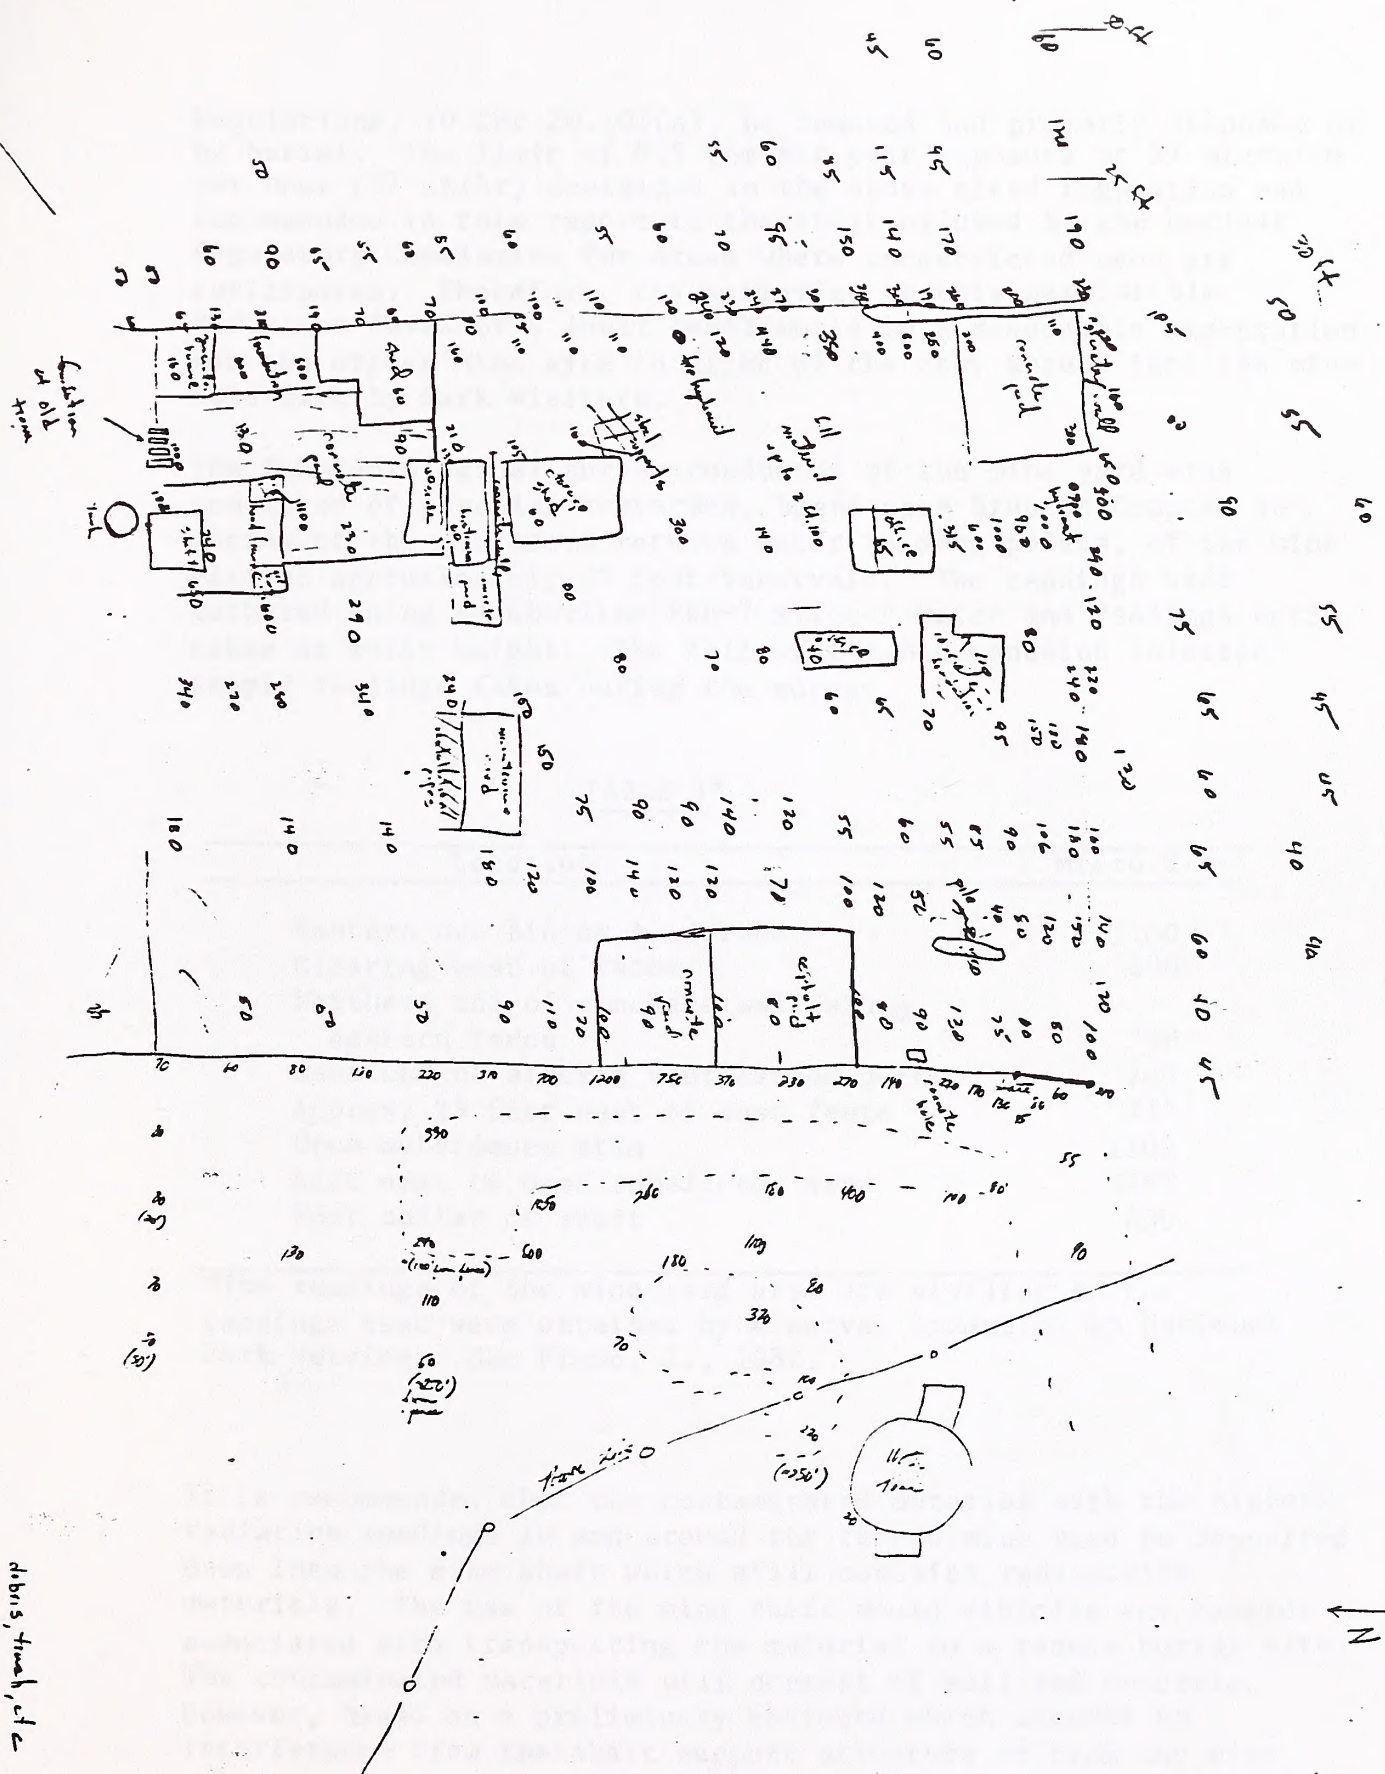
FIGURE 5

4. **SHAFT AND CONTAMINATED MATERIALS.** Based upon the BLM radiological survey, the area in and around the mine yard is emitting low levels of radiation. Two explanations of the source of the low level radiation would be that material from the mine was used as fill when the mine yard site was being prepared and/or the random scattering of uranium ore by men and equipment during the active mining periods. In addition, it appears that low level radioactive material was transported by wind and water action to the Park lands adjacent to the fenced mine yard. Please refer to Figure 4 which shows the area, approximately 5.6 acres in size, where contamination has occurred. Figure 5 is a sketch copy of the mine yard area which shows the readings taken during the radiological survey.

This sketch depicts the Orphan Mine yard area and shows the relative location of radiation readings (in uR/hr).

Regulations, 10 CFR 20.105(a), be removed and properly disposed of by burial. The limit of 0.5 rem per year exposure or 57 microrem per hour (57 uR/hr) contained in the above cited regulation and recommended in this report is the limit allowed by the Nuclear Regulatory Commission for areas where unrestricted uses are anticipated. Therefore, the achieving of this permissible radiation level or a lower level would be a reasonable expectation for the Orphan Mine site in light of the easy access into the mine yard area by Park visitors.

The BLM radiological survey conducted of the mine yard area consisted of parallel traverses, based upon Brunton Compass and pacing of the distances between meter reading points, of the mine yard at approximately 25 foot intervals. The readings were gathered using an Eberline PRM-7 Micro R meter and readings were taken at waist height. The following table contains selected sample readings taken during the survey.

It is recommended that the contaminated material with the highest radiation readings in and around the fenced mine yard be deposited down into the mine shaft which still contains radioactive materials. The use of the mine shaft would minimize any hazards associated with transporting the material to a remote burial site. The contaminated materials will consist of soil and concrete. However, based on a preliminary estimate which assumes no interference from the shaft support structure or from any mine support equipment such as air and water lines, the total volume of contaminated material will exceed the volume of the mine shaft by 100 to 200%. Therefore, the material with lower radiation readings will either have to be transported to a remote burial site or buried on site. Contaminated material located off the edge of the rim should also be recovered but may be difficult to reach with

Once the shaft has been filled to within six feet of the surface with contaminated material, the shaft should be sealed with a 4 foot concrete cap and then 2 feet of top soil. The concrete cap should be so designed that it is anchored into the sides of the shaft so that future settling of the contaminated material will not cause the cap to settle. In addition to isolating the contaminated material, the capping of the shaft will prevent further escape of radon gas which is also a health hazard.

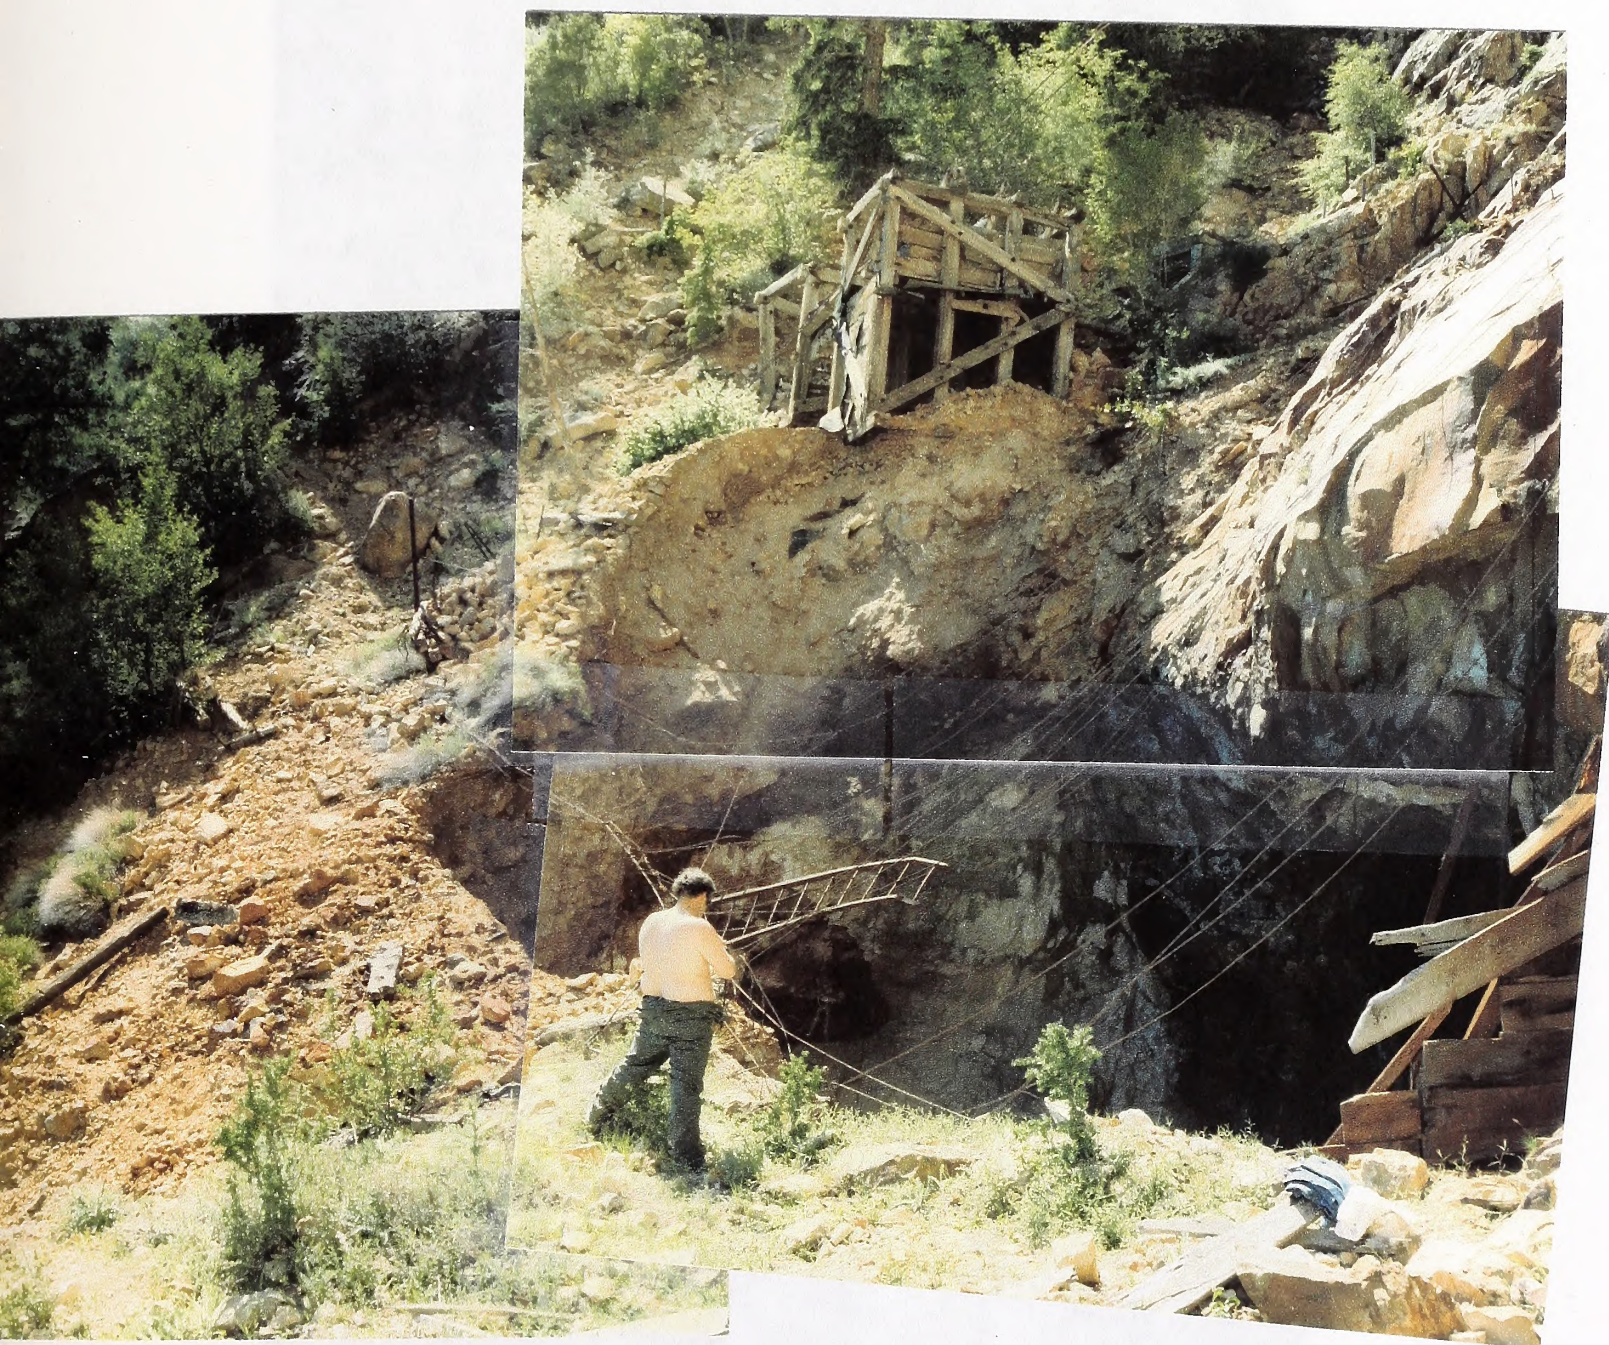
The surface disturbance in the area of the breccia pipe is confined to an area that is smaller than the mine yard. The most prominent feature in this area is the open hole, approximately 30 feet in diameter and 200 to 300 feet in depth, that resulted when the surface subsided into the old underground mine workings. The adit is located on the western edge of the opening. The open hole appears to be getting larger at the surface. This is due to the fact that loose unconsolidated material that surrounds the hole on the down slope is being washed into the opening or material is sloughing off the slope of the opening into the hole at other times.

PHOTO #5: This photo is a closeup view of the open subsidence hole and low aerial tramway tower shown in Photo #4. The cables and wooden planks were an apparent attempt to isolate the open hole from men and equipment in the area.

5. SUBSIDENCE AREA. Due to the remoteness and size of the open hole that was created when the surface subsided into the old underground mine workings, the only practical recommendation to reclaim the area would be to construct a heavy duty chain link fence so that wildlife and hikers would be kept a safe distance from the subsidence hole. The location of the fence must take into account that the top of the hole has not yet completely stabilized. Danger and radiation warning signs should be posted on the fence to warn Park visitors who may venture into the area of the dangerous situation.

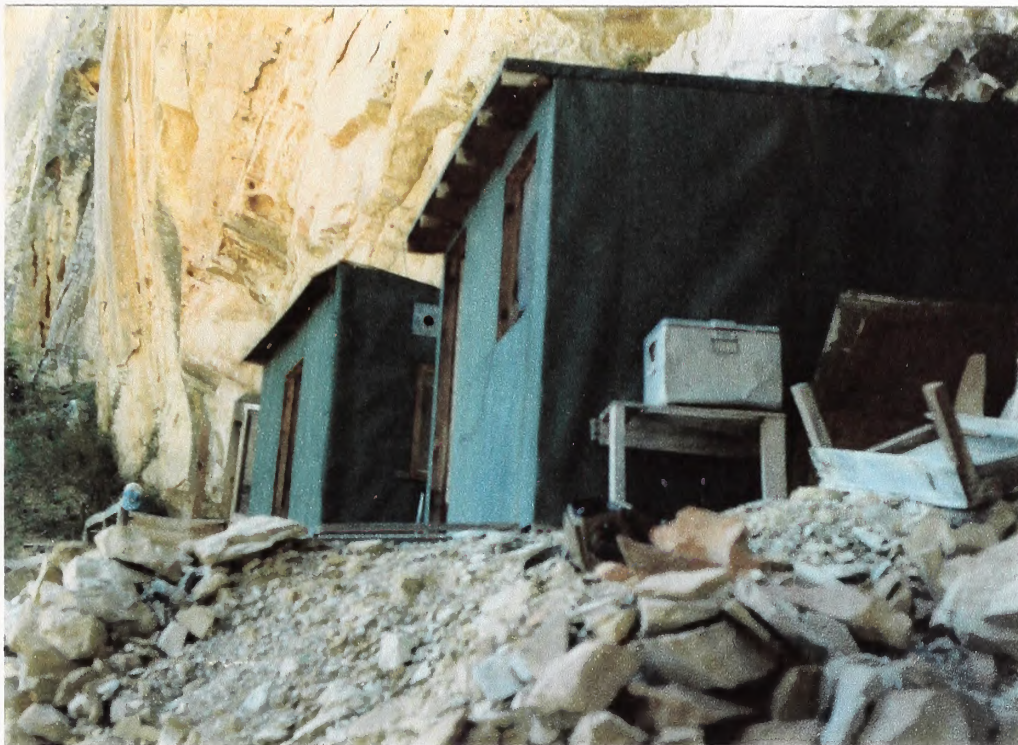
PHOTO #6: A view of the bunkhouses located at the lower adit area of the Orphan Mine. The ledge that these structures sit on is located at the left of top center of Photo #4.

The structures, including the bunkhouses and the return tramway tower, located in the adit area have no salvage value because of their remote location and should be dismantled and disposed of by depositing into the open subsidence hole. This recommendation would be more cost effective than transferring the material by
